The influence of the use of regulatory codes on the diagnosis of pathologies of reinforced concrete frame bridges

3. Investigative inquiry on the expertized bridge

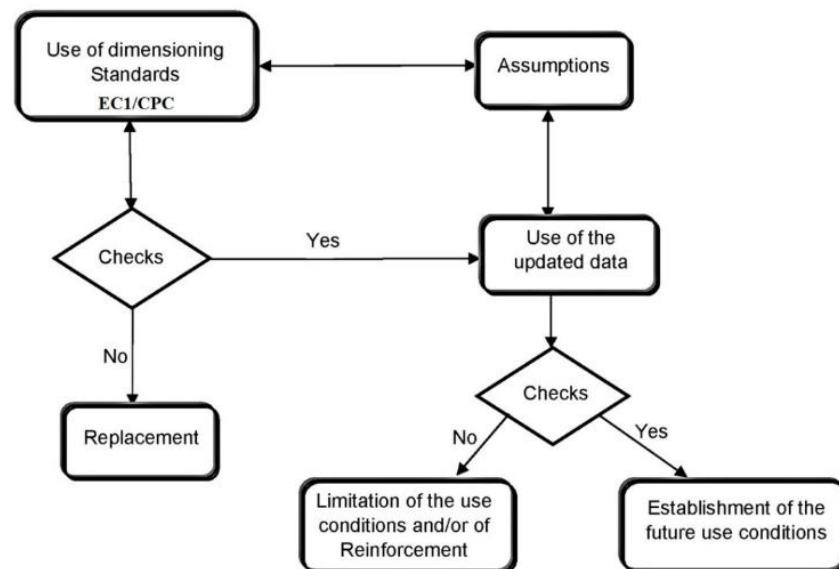
The Figure 1 illustrates in a diagram the principle of valuation, which begins with the use of the norms dimensioning in force which are in this article CPC fascicle 61 title II (Fascicle 61, 1961) and the Eurocode 1 (Eurocode 1, 1997) and which is identical to that of the dimensioning of new structures. In addition, this method generally has the advantage of facilitating the rapid identification of the key elements or sections of the construction.

Figure 1 - Evaluation principal flow chart. Source: Authors (2023).

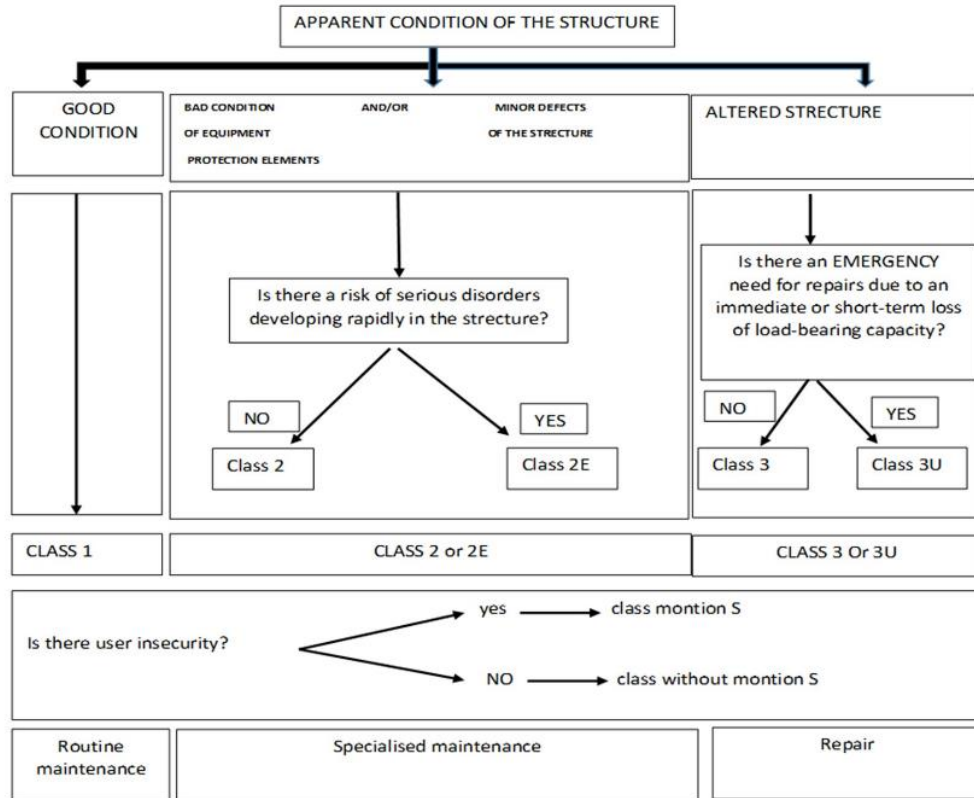
The process used to determine the conditional class in which a bridge should be classified is summarized in the flowchart in Figure 3. The decision's elements are based on a set of notions and terms relating to the different parts of the bridge to be considered, and to the type of intervention required. Due to the imprecise nature of the terms "Maintenance" and "Repair" used in this flowchart, the classification of the structure should be carried out from top to bottom of the decision tree, rather than the other way round.

Figure 3 - The process of assessing status class according to the IQOA. Source: (SETRA, 1996)

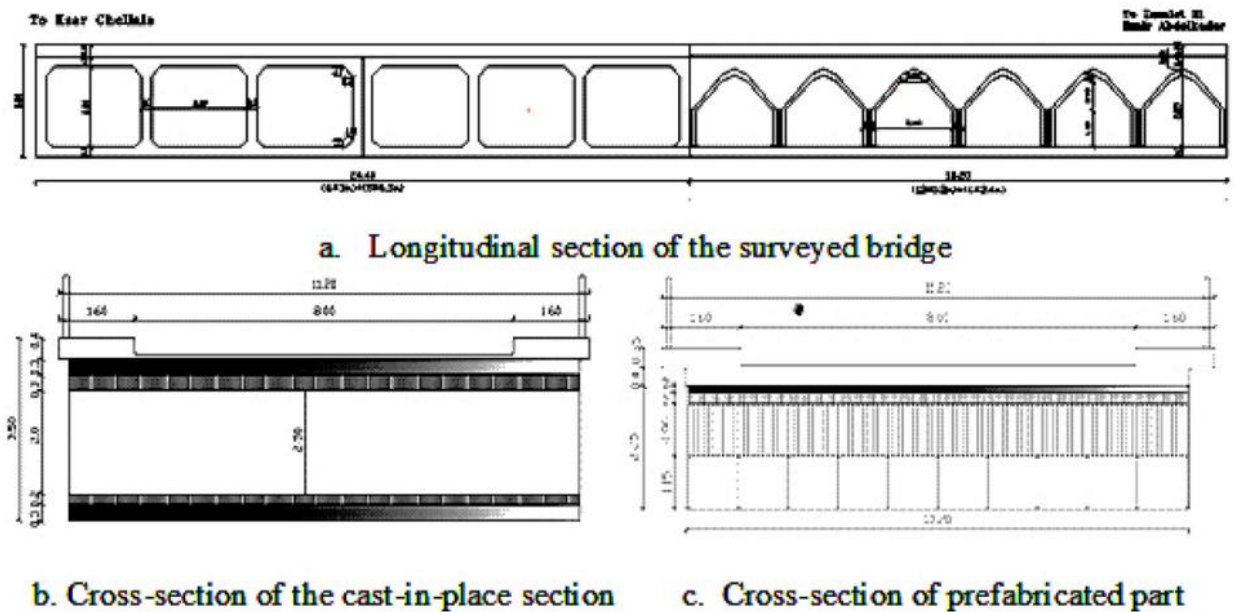
Its main traffic consists of cars, tractors and trucks. The bridge, which has been surveyed, is classified according to the Algerian seismic regulations RPOA version 2008 (RPOA, 2008) in zone I, meaning low seismicity, and in group 2 of importance class (major bridge). The total length of the bridge is 37.2 m, and it consists of two sections: the first, built in 1994, has a length of 20.40 m and comprises 6 cast-in-place reinforced concrete scuppers, and the second, built in 1997, has a length of 16.80 m and comprises 6 prefabricated reinforced concrete scuppers. The longitudinal section and two cross-sections of the bridge are represented in Figure 7.

Figure 7 - Sections of the tested bridge. Source: Authors (2023).

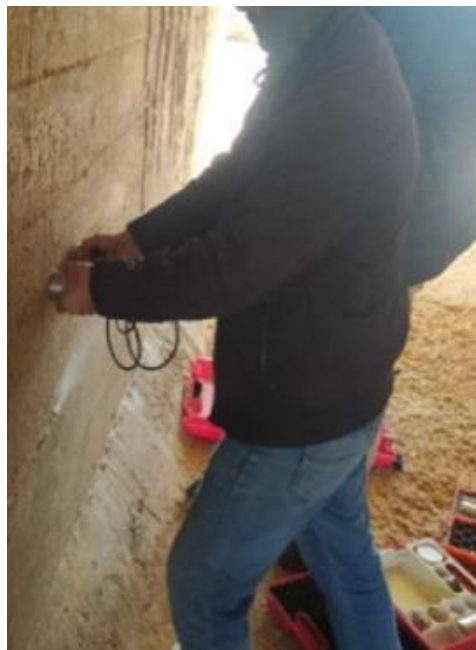
The measuring equipment used is a TICO-type ultrasound (Figure 9), which enables measurements to be taken using the surface method (indirect measurement).

Figure 9 - Measurement of propagation speed (TICO-type ultrasound). Source: Authors (2023).

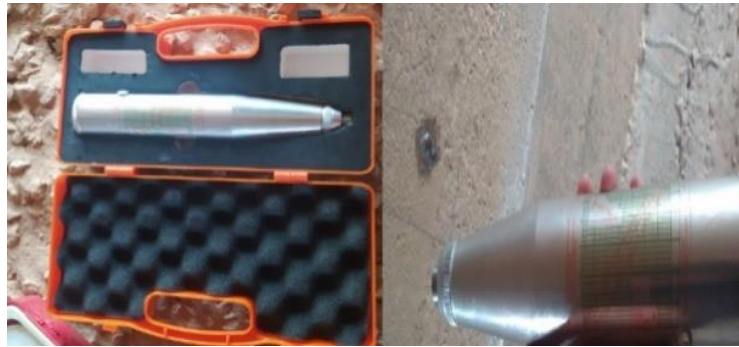
The second test determines the rebound index of a hardened concrete surface in accordance with NA 2786, which can be used to assess the homogeneity of concrete in situ. Simple compression tests in accordance with NA 5075 determine the compressive strength (Figure 10).

Figure 10 - Concrete strength measurement apparatus (concrete sclerometer). Source: Authors (2023).

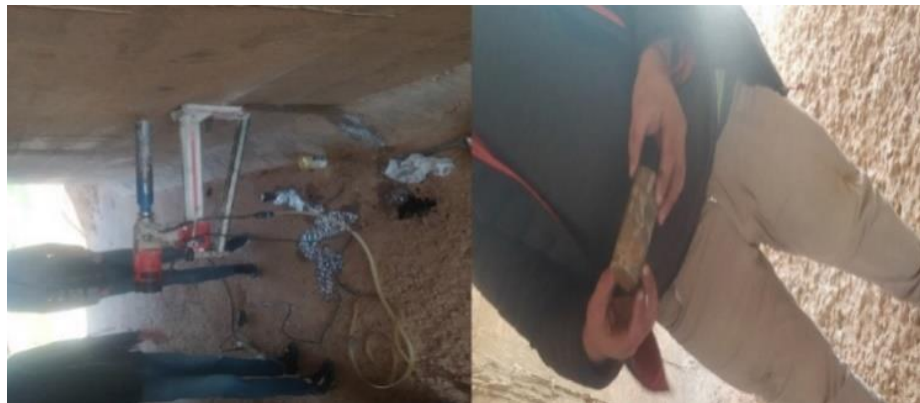
Carbonate thickness at the facing is measured in accordance with standard NF EN 14630 in the laboratory on freshly broken core samples (Figure 11) taken from the bridge (split along a generatrix). Phenolphthalein is colourless at pH below 8.2 and deep pink at pH above 9.9.

Figure 11 - Concrete core samples. Source: Authors (2023).

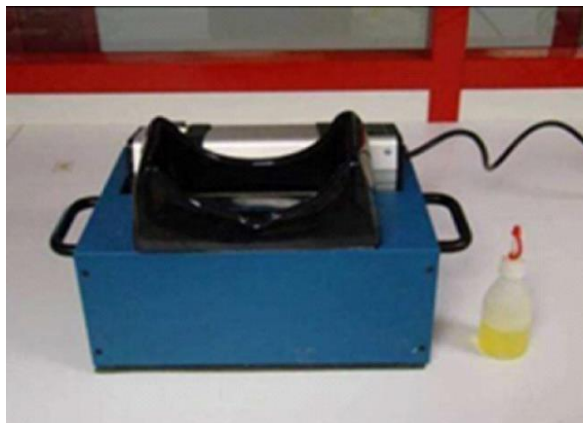
The final test consists in determining the presence of chlorides in the mortar facing, in accordance with UNI 7928 standards. This measurement is carried out in the laboratory on freshly broken core samples taken from the bridge (split along a generatrix). In the presence of free chloride, the mortar takes on a light grey colour (Figure 12).

Figure 12 - Analysis of ion chromatography for free chloride ions. Source: Authors (2023).

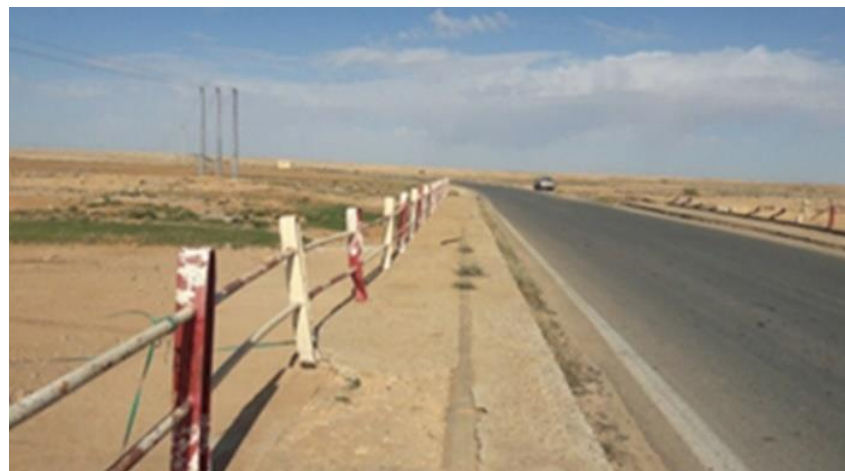
Nature of degradation	Probable causes
EQUIPMENTS	<ul style="list-style-type: none"> - Damaged guard rail (Figure 15). - Damaged paintwork on guard rail. - Corrosion of guard rail. - Localized alignment fault. - Missing tubular elements. 	<ul style="list-style-type: none"> - Lack of maintenance

Figure 15 - Visual damage to bridge equipment. Source: Authors (2023).

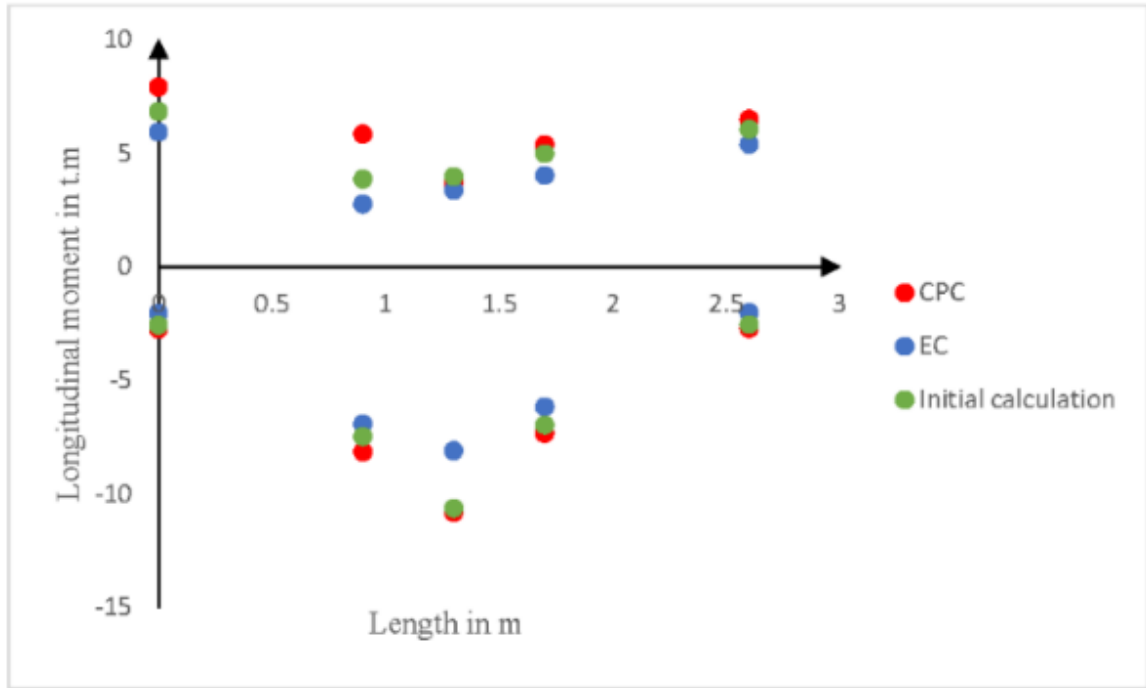
Figure 23 - Maximum moments calculated by EC1 (Eurocode 1, 1997) and CPC (Fascicle 61, 1961) compared with moments calculates by initial data (pre-cast part). Source: Authors (2023).

The results of the global extremes show that the Eurocode moment values with the current bridge data remain lower than the global extremes calculated with the initial data, in contrast to those calculated by CPC (Fascicle 61, 1961) with the current data. Since the moments calculated by Eurocode 1 (Eurocode 1, 1997) are lower than the values calculated by the bridge's initial data, the variation will be counted as negative for the calculation made by Eurocode 1 (Eurocode 1, 1997) and positive for the calculation made by CPC (Fascicle 61, 1961). These variations are listed in Table 10 below.

It is clear that the calculations carried out by Eurocode1 (Eurocode 1, 1997) are lower than the values calculated by the initial bridge data with rates varying from 10.09% to 23.87%, unlike the calculations carried out by CPC (Fascicle 61, 1961) which exceed the initial calculations by a rate varying from 1.69% to 19.22%.
