Predictive response to the behaviour of old structures using ambient vibrations

2-1 Presentation of the case study "the El-Badr mosque, former Saint Jean-Baptiste church"

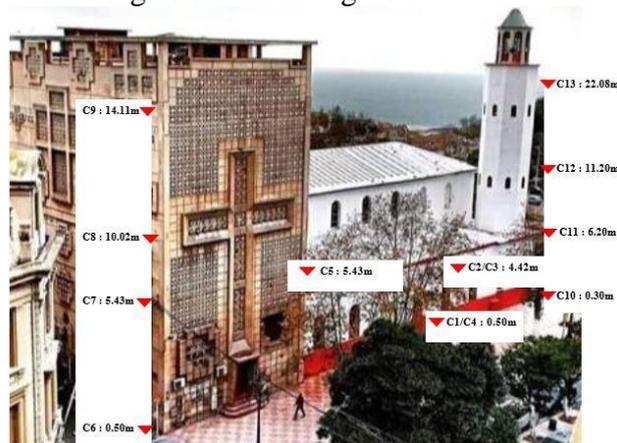
For each recording, averaging 10 to 15 minutes (El-Borgi, S., 2008), the location of the fixed sensor used as reference was studied beforehand so as not to coincide with a node, i.e. a location that remains stationary while three mobile sensors or wick sensors are moved from one recording to another (Paquette, L.G., 2012). The seismometers represented by the abbreviations C1 to C13 have been positioned in the North-South direction indicated by NS, this direction follows the longitudinal direction of the building as shown in Figure 1.

Figure 1 - Location of the sensors on the structures.

Thus, the NS component corresponds to the longitudinal horizontal motion North-South, while the East-West direction indicated by the abbreviation EW corresponds to the transverse direction of horizontal movement and Z presents the vertical direction of mouvement (Chatelain, J.L. and al., 2012; Paquette, L.G., 2012).

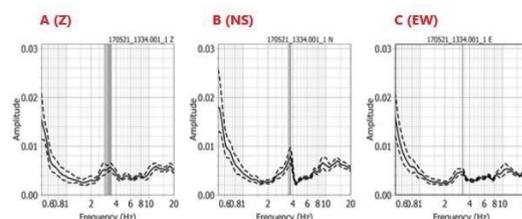
Since it was not possible to place the collectors directly on the timbered roof, we placed them at mid-height (4.42 m for seismometers C2 and C3 and 5.43 m for the seismometer C5 as shown in Figure 1, which allows us to verify that the deformations measured on the roof follow the general trend of the building (Paquette, L.G., 2012), i.e. the vertical Z component at the top). The Figure 2 to Figure 4, and Table 1S to Table 3S (see supplementary material) shows the modal frequencies of the first recording in the prayer room:

Figure 2 - Response spectrum of the signals recorded by the C1 sensor.

In most of the sensors (C1, mode 2 of C3, C4, C5) (see Figure 2, Figure 4 to Figure 6 and supplementary material in Table 1S, Table 3S to Table 5S), the frequencies of the prayer hall in the NS directions are higher than those in the EW direction, which explains why there is a greater stiffness in the longitudinal direction (Mikael, A., 2011); in fact, the particular characteristics of Christian religious buildings, is that the two side walls with timid openings of a Romanesque design are characterised by a squat architecture and a low slenderness of the load-bearing walls, with a thickness of 65 cm to 70 cm resting on a string of arches highlighting the central nave, and makes the side walls more flexible than the North and South fronts. It is also the effectiveness of this connection that causes the torsional component of the bending mode (Chabane, S. and al., 2019; Kibboua, A. and al., 2008), so in terms of displacement this remains minimal. These explanations can be also linked to the random decrement method, which can increase the values of one direction relative to another.

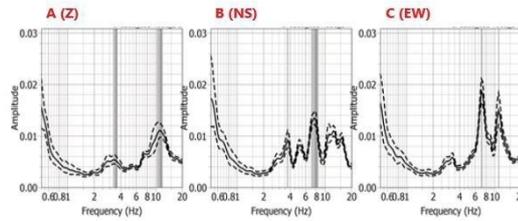
Figure 3 - Response spectrum of the signals recorded by the C2 sensor.

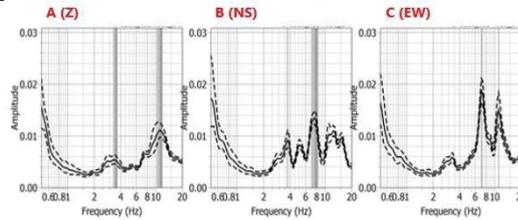
Figure 4 - Response spectrum of the signals recorded by the C3 sensor.

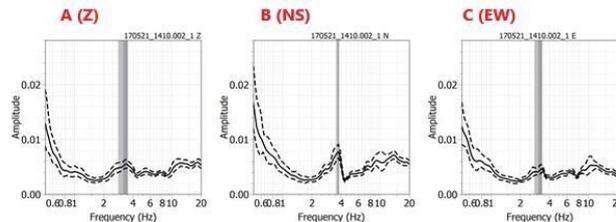
The Figure 5, Figure 6, and Table 4S to Table 5S (see supplementary material) shows the modal frequencies of the second recording in the prayer hall:

Figure 5 - Response spectrum of the signals recorded by the C4 sensor.

between the prayer hall and the sacristy by the C5 sensor (11.85 Hz, 10.63 Hz and 8.81 Hz) (see Figure 6 and supplementary material in Table 5S), and at the junction between the prayer hall and the two structures of the minaret and the ablution room, recorded by the C2 and C3 sensors (7.11 Hz, 11.08 Hz, 5.14 Hz, 11.07 Hz, 7.61 Hz) (see Figure 3 and supplementary material in Table 2S) for the C2 sensor and (10.69 Hz, 5.18 Hz, 7.11 Hz, 7.59 Hz, 11.05 Hz and 11.16 Hz) (see Figure 4 and supplementary material in Table 3S) for the C3 sensor, these values significantly exceed the frequencies recorded by the reference sensors placed on the ground (C1 and C4) (see Figure 2, Figure 5 and supplementary material in Table 1S, Table 4S).

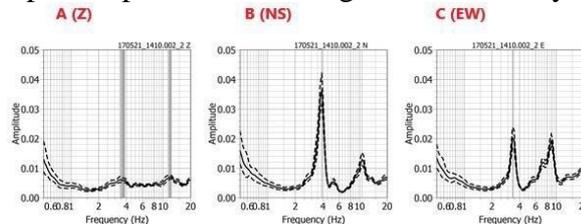
Figure 6 - Response spectrum of the signals recorded by the C5 sensor.

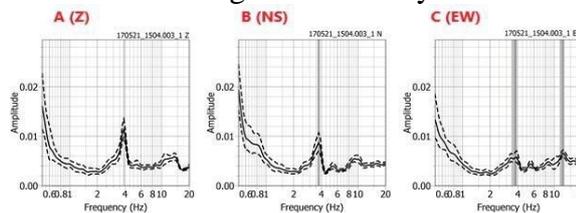
Sacristy: For the sacristy, the data are collected by seismometers C6, C7 and C9 (wick sensors), C8 (reference sensor), placed on each floor from the ground floor to the third floor as shown in Figure1. The Figure 7 to Figure 10, and Table 6S to Table 9S (see supplementary material) shows the modal frequencies of the recording in the sacristy:

Figure 7 - Response spectrum of the signals recorded by the C6 sensor.

For the horizontal transverse component EW, two recordings of 3.65 Hz and a frequency peak of 12.07 Hz at the C6 sensor (see Figure 7 and supplementary material in Table 6S) and the value of 3.75 Hz at the C8 sensor (see Figure 9 and supplementary material in Table 8S), very low or even negligible amplitude and frequency values were observed for the C7 and C9 sensors (see Figure 8, Figure 10 and supplementary material in Table 7S, Table 9S).

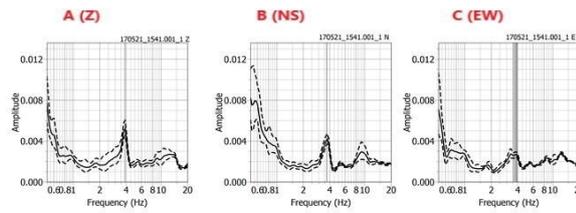
Figure 9 - Response spectrum of the signals recorded by the C8 sensor.

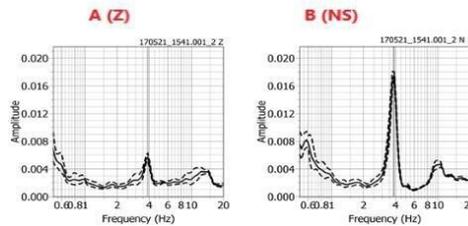
Figure 10 - Response spectrum of the signals recorded by the C9 sensor.

Sacristy: The sacristy has the lowest frequencies, ranging from 3.65 Hz to 12.07 Hz. The building has a certain symmetry in plan and elevation, except in a few places, such as the location of the staircase on the south-south/west side on the ground floor, which goes from the second floor to the north-north/west, and the presence of a balcony in the third floor in the choir hall, creating a double height of more than 5 m for this floor. This explains the slight difference in the frequency values of the vertical Z components (3.88 Hz for the C6 and C7 sensors) (see Figure 7, Figure 8 and supplementary material in Table 6S, Table 7S), and (3.86 Hz for the C8 and C9 sensors) (see Figure 9, Figure 10 and supplementary material in Table 8S, Table 9S).

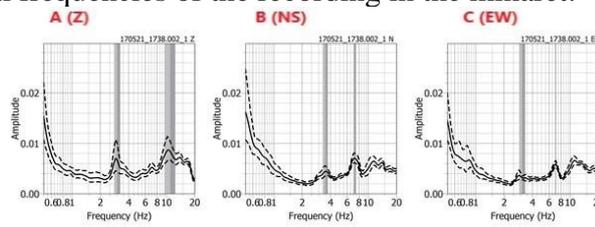
Minaret: For the minaret, the data set is obtained from seismometers C10, C12 and C13 (wick sensors), C11 (reference sensor), placed at the locations of each level from 0.3 m to 22.08 m as shown in Figure 1. The Figure 11 to Figure 14, and Table 10S to Table 13S (see supplementary material) shows the modal frequencies of the recording in the minaret:

Figure 11 - Response spectrum of the signals recorded by the C10 sensor.

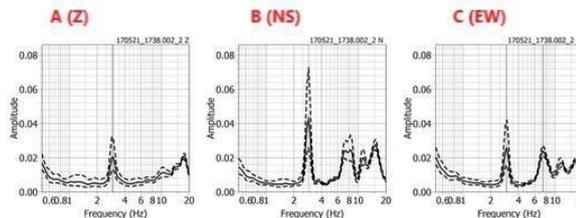
Figure 12 - Response spectrum of the signals recorded by the C11 sensor.

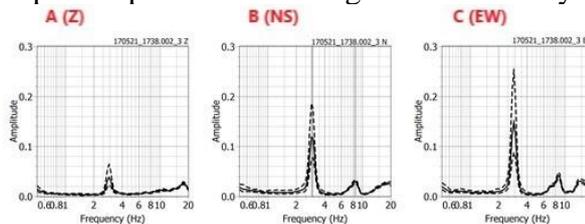
Figure 13 - Response spectrum of the signals recorded by the C12 sensor.

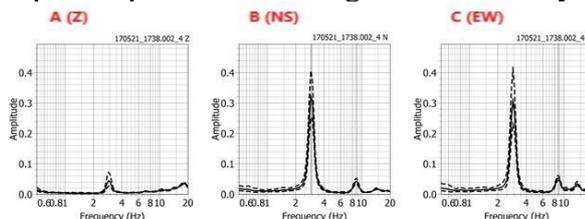
Figure 14 - Response spectrum of the signals recorded by the C13 sensor.

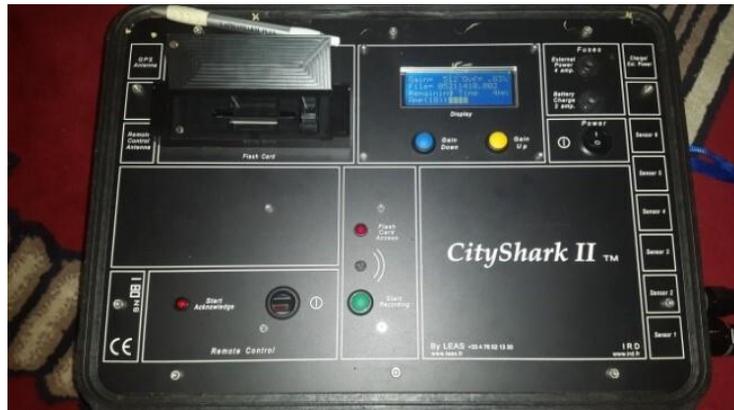
Figure 1S. Station used for background noise.

The whole building was instrumented with several series of measurements because of the different blocks and the number of sensors (four Lennartz velocimeters three-component with the Cityshark II station, see supplementary material in Figure 1S and Figure 2S) (Benkaci, N. and al., 2021; Chatelain, J.L. and al., 2012; Kibboua, A., 2006; Kibboua, A. and al., 2008), cables are needed to complete the circuit with the recording station and a laptop for signal processing. Given the irregular shape of the structure, the arrangement of the sensors was designed to avoid redundancy and to illustrate the actual modes (Paquette, L.G., 2012).

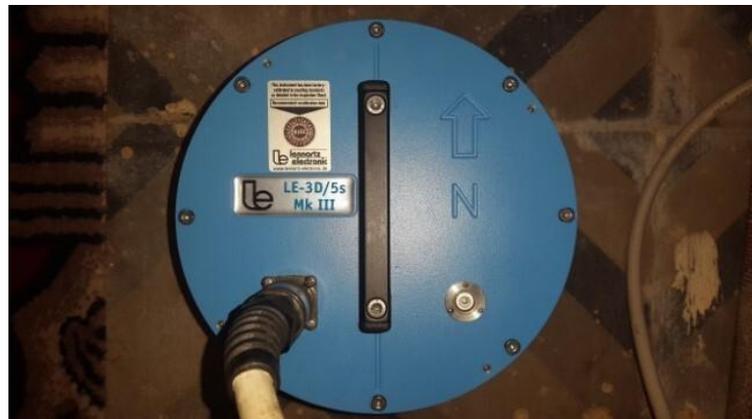
Figure 2S - Sensor used for background noise.

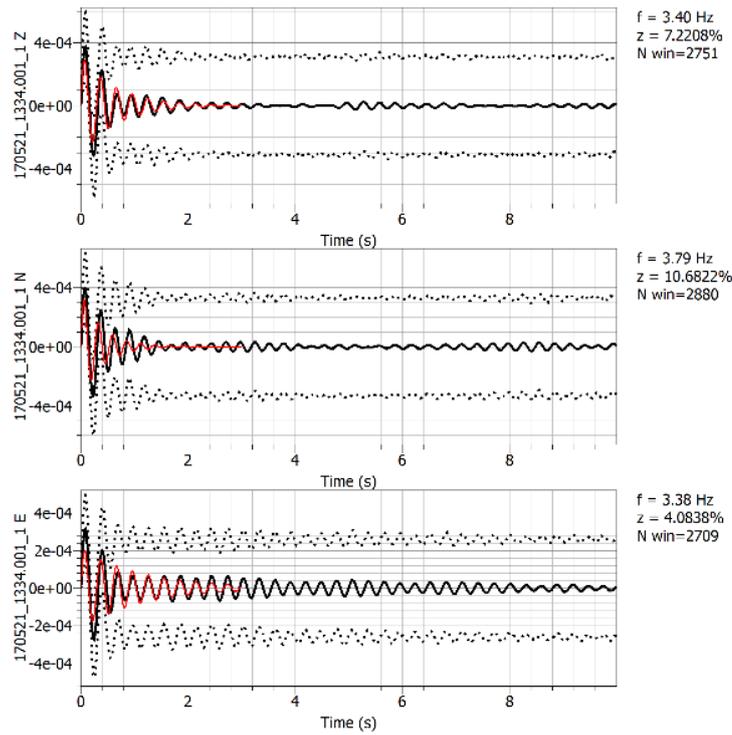
Figure 3S- Values of the damping coefficient at the recording point C1.

Directions	Frequencies / Hz	Damping / %
Vertical Z	3.4	7.22
Longitudinal NS	3.79	10.68
Transversal EW	3.38	4.08

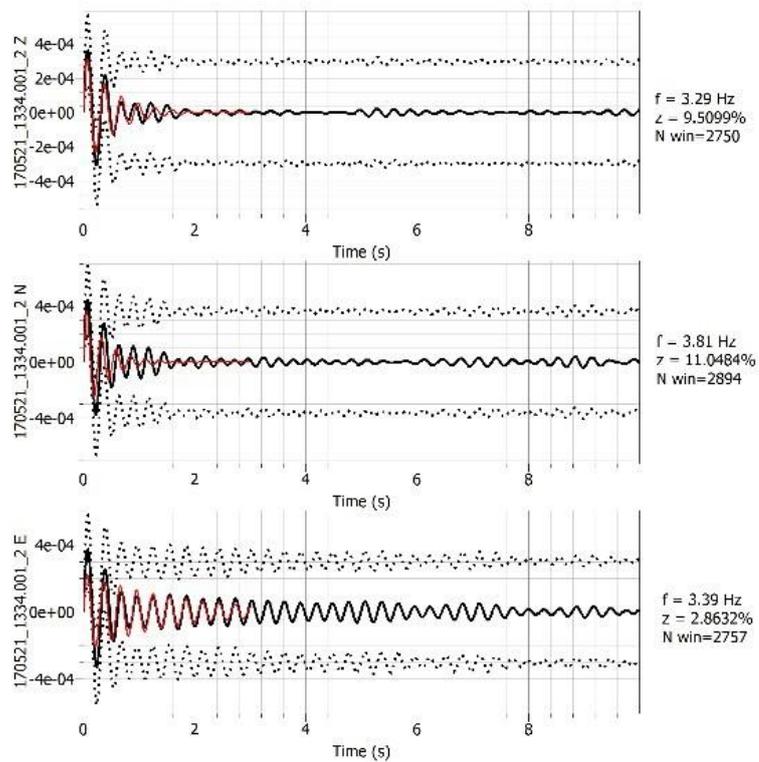
Figure 4S- Values of the damping coefficient at the recording point C2 between 2 Hz - 4 Hz.

Directions	Frequencies / Hz	Damping / %
Vertical Z	3.29	9.50
Longitudinal NS	3.81	11.04
Transversal EW	3.39	2.86

Or, the decrease of the coefficient is observed with the increase of the frequencies in certain directions of the C2 sensors, between 2 Hz - 4 Hz in the horizontal direction EW (see Table 2 and supplementary material in to Figure 4S), of the C3 sensor, between 6 Hz - 8 Hz in all directions (see Table 6 and supplementary material in to Figure 8S), between 8 Hz - 12 Hz in the horizontal directions NS and EW (see Table 7, supplementary material in to Figure 9S), and for the C5 sensor, between 2 Hz - 4 Hz in the horizontal directions NS and EW (see Table 9 and supplementary material in to Figure 11S), where even the lowest coefficient of 0.46% in the EW direction, between 8 Hz-12 Hz in all directions (see Table 10 and supplementary material in to Figure 12S). These sensors are located in the upper part of the hall and their values are justified by the movement that can be generated by the wooden framework, which has its own response and influences the values of the mentioned sensors.

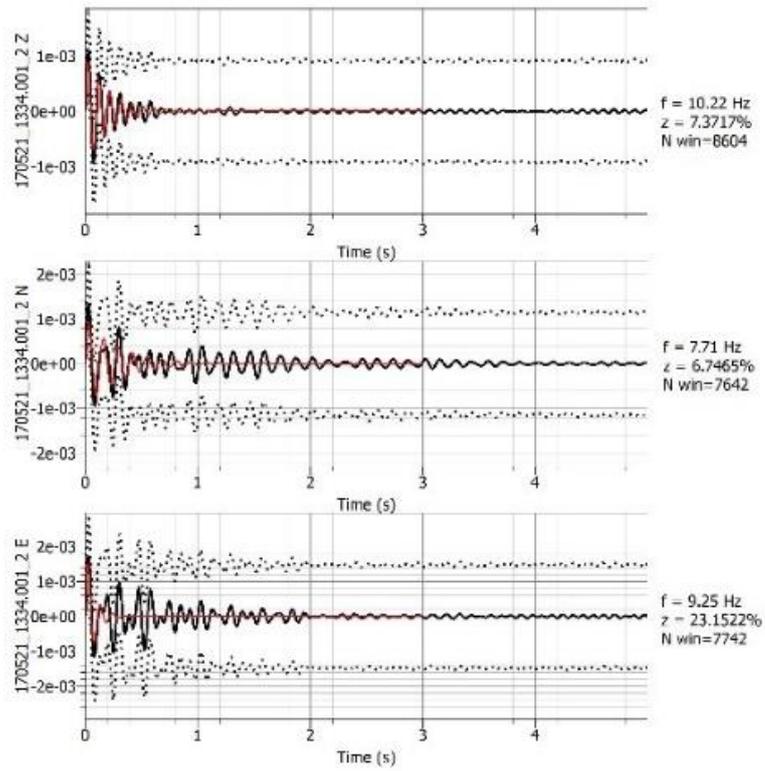
Figure 5S- Values of the damping coefficient at the recording point C2 between 6 Hz - 12 Hz.

Directions	Frequencies / Hz	Damping / %
Vertical Z	10.22	7.37
Longitudinal NS	7.71	6.74
Transversal EW	9.25	23.15

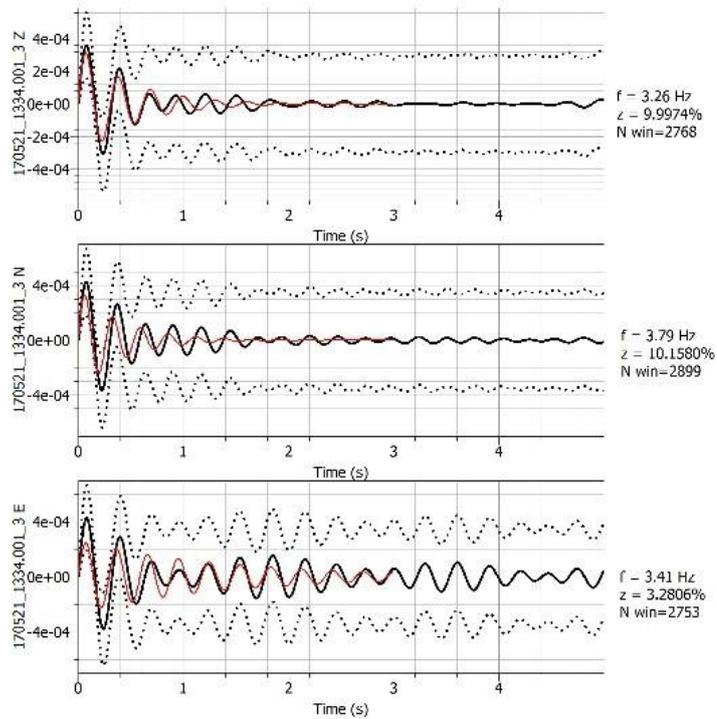
Figure 6S- Values of the e damping coefficient at the recording point C3 between 2 Hz- 4 Hz.

Directions	Frequencies / Hz	Damping / %
Vertical Z	3.26	9.99
Longitudinal NS	3.79	10.15
Transversal EW	3.41	3.28

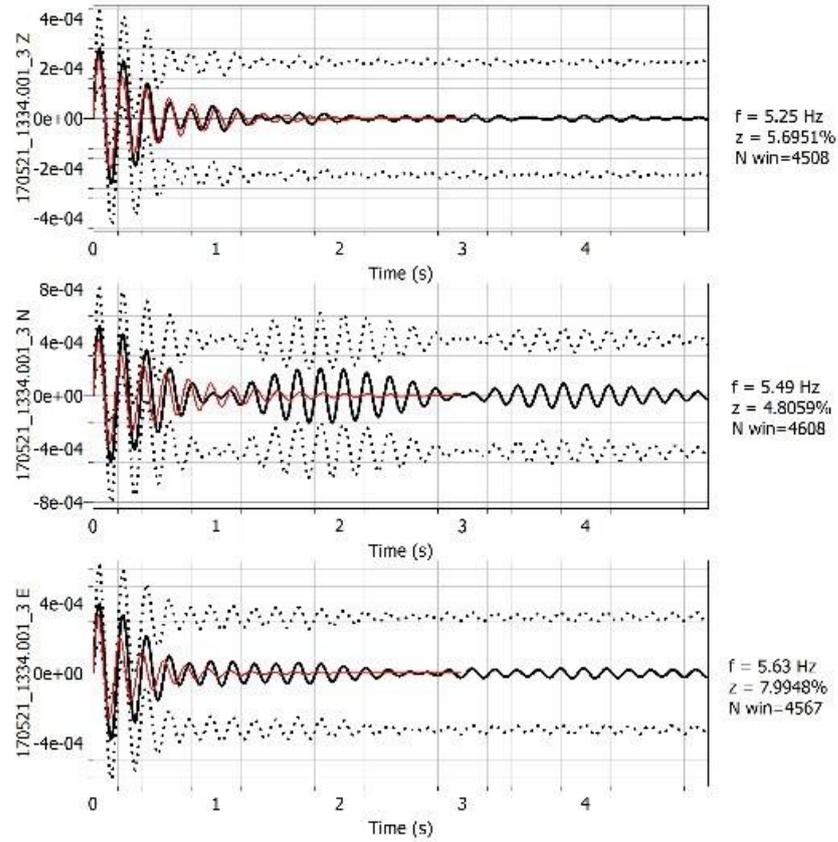
Figure 7S- Values of the e damping coefficient at the recording point C3 between 4 Hz- 6 Hz.

Directions	Frequencies / Hz	Damping / %
Vertical Z	5.25	5.69
Longitudinal NS	5.49	4.80
Transversal EW	5.63	7.99

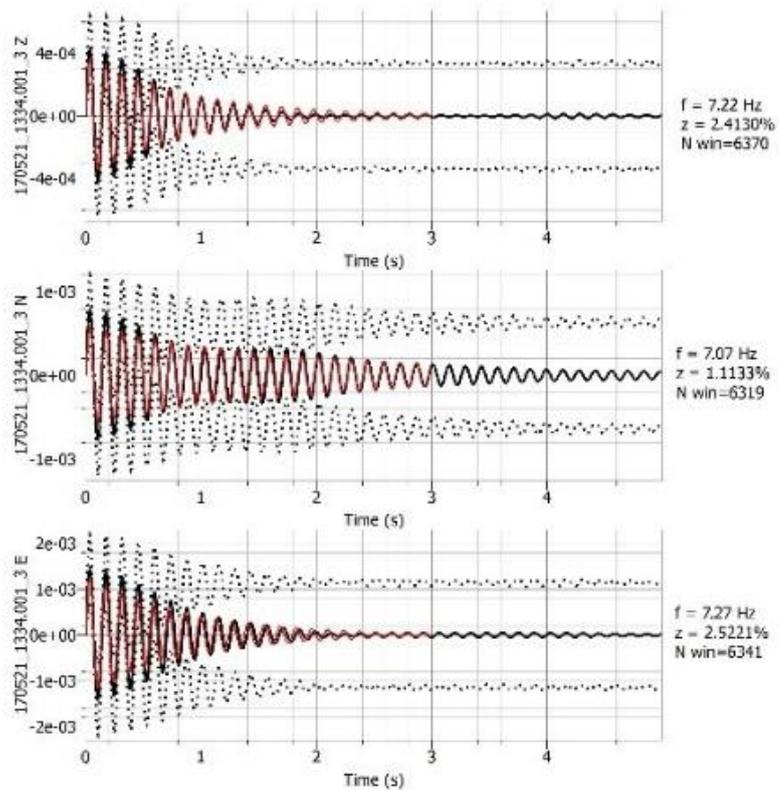
Figure 8S- Values of the e damping coefficient at the recording point C3 between 6 Hz- 8 Hz.

Directions	Frequencies / Hz	Damping / %
Vertical Z	7.22	2.41
Longitudinal NS	7.07	1.11
Transversal EW	7.27	2.52

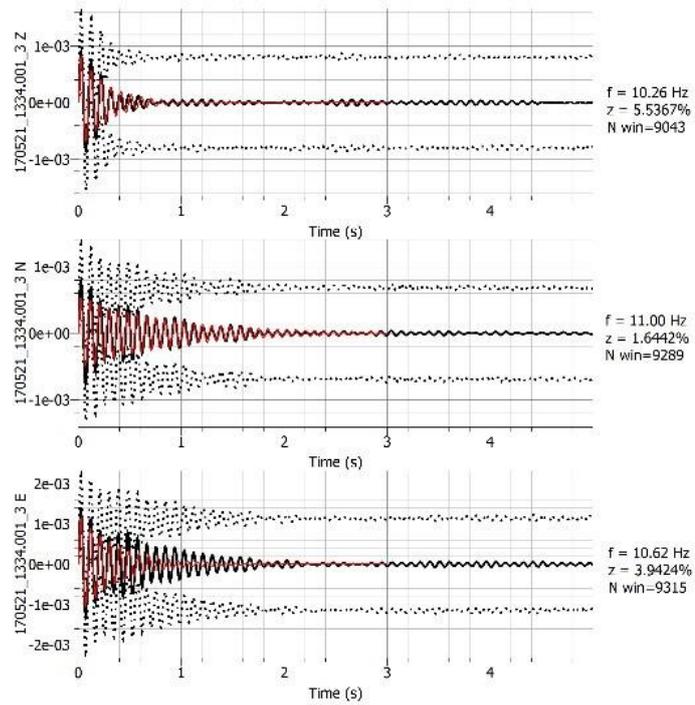
Figure 9S-Values of the e damping coefficient at the recording point C3 between 8 Hz- 12 Hz.

Directions	Frequencies / Hz	Damping / %
Vertical Z	10.26	5.53
Longitudinal NS	11	1.64
Transversal EW	10.62	3.94

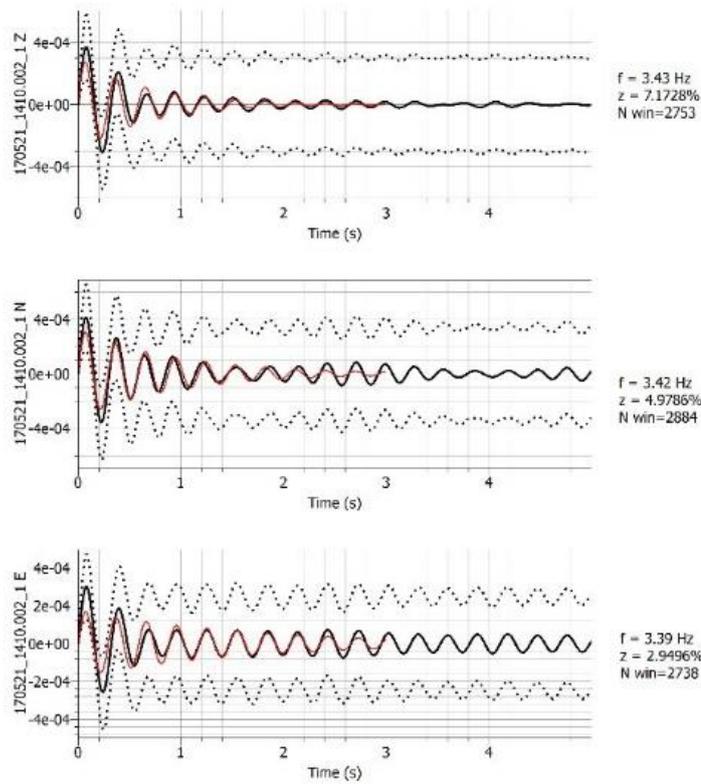
Figure 10S- Values of the damping coefficient at the recording point C4.

Directions	Frequencies / Hz	Damping / %
Vertical Z	3.43	7.17
Longitudinal NS	3.42	4.97
Transversal EW	3.39	2.94

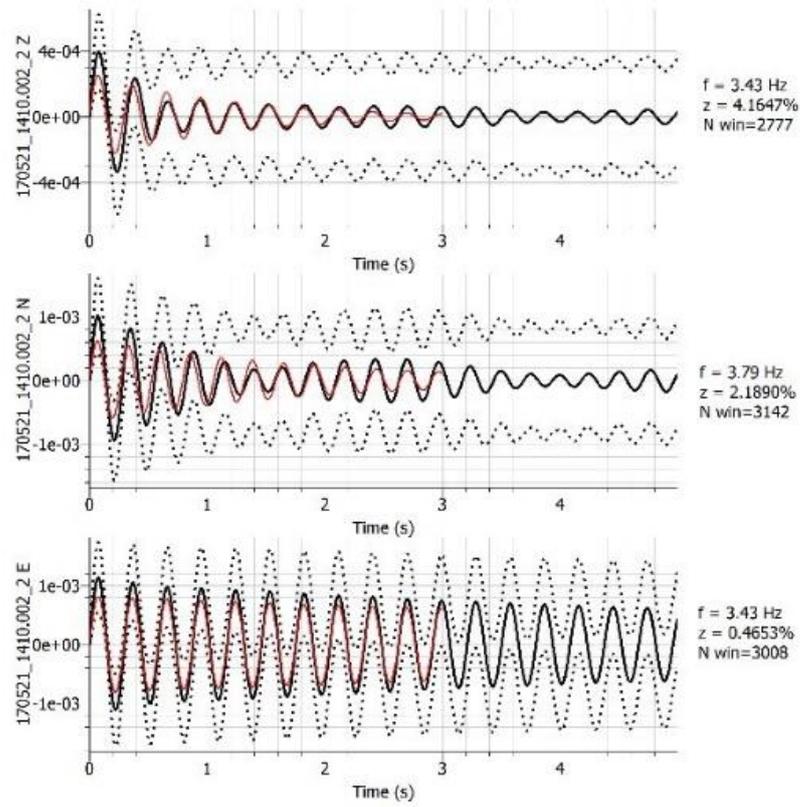
Figure 11S- Values of the damping coefficient at the recording point C5 between 2 Hz - 4 Hz.

Directions	Frequencies / Hz	Damping / %
Vertical Z	3.43	4.16
Longitudinal NS	3.79	2.18
Transversal EW	3.43	0.46

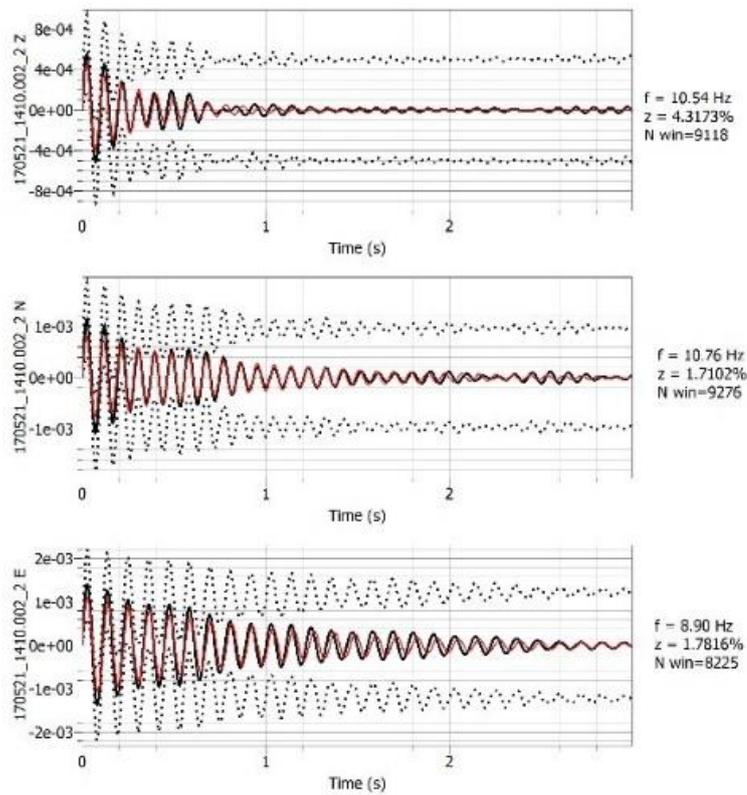
Figure 12S- Values of the damping coefficient at the recording point C5 between 8 Hz - 12 Hz.

Directions	Frequencies / Hz	Damping / %
Vertical Z	10.54	4.31
Longitudinal NS	10.76	1.71
Transversal EW	8.90	1.78

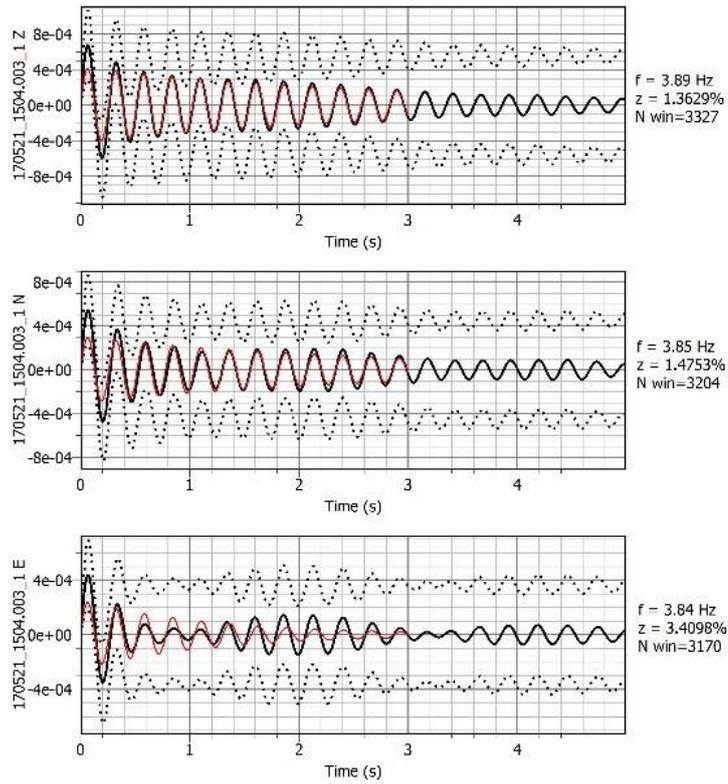
Figure 13S- Values of the damping coefficient at the recording point C6.

Directions	Frequencies / Hz	Damping / %
Vertical Z	3.89	1.36
Longitudinal NS	3.85	1.47
Transversal EW	3.84	3.40

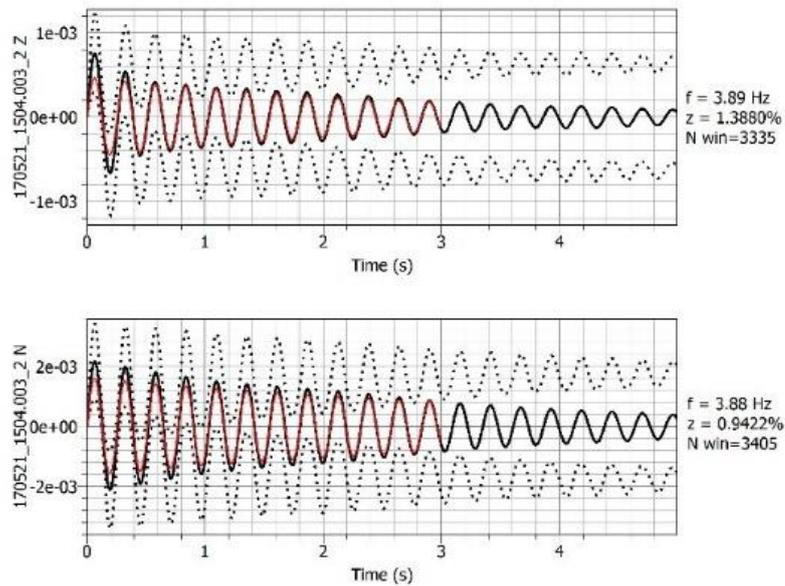
Figure 14S- Values of the damping coefficient at the recording point C7.

Directions	Frequencies / Hz	Damping / %
Vertical Z	3.89	1.38
Longitudinal NS	3.88	0.94
Transversal EW	negligible value	negligible value

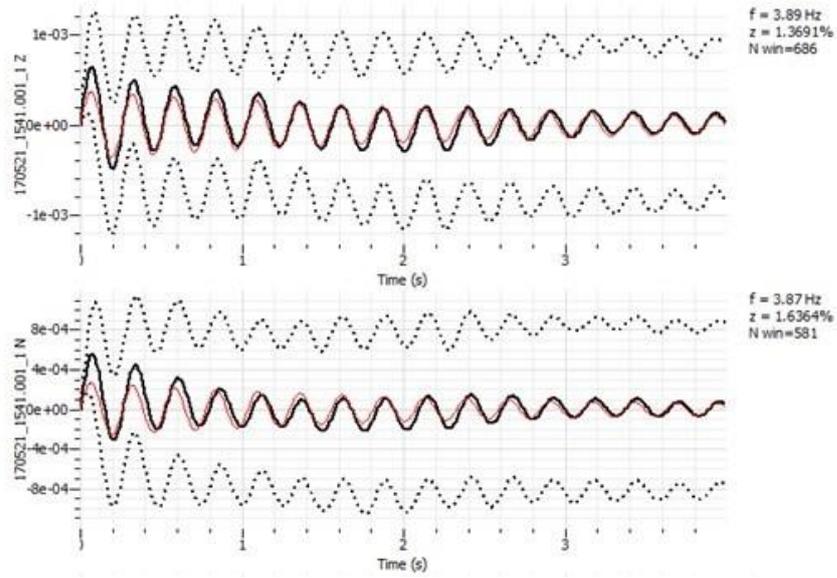
Figure 15S- Values of the damping coefficient at the recording point C8.

Directions	Frequencies / Hz	Damping / %
Vertical Z	3.89	1.36
Longitudinal NS	3.87	1.63
Transversal EW	negligible value	negligible value

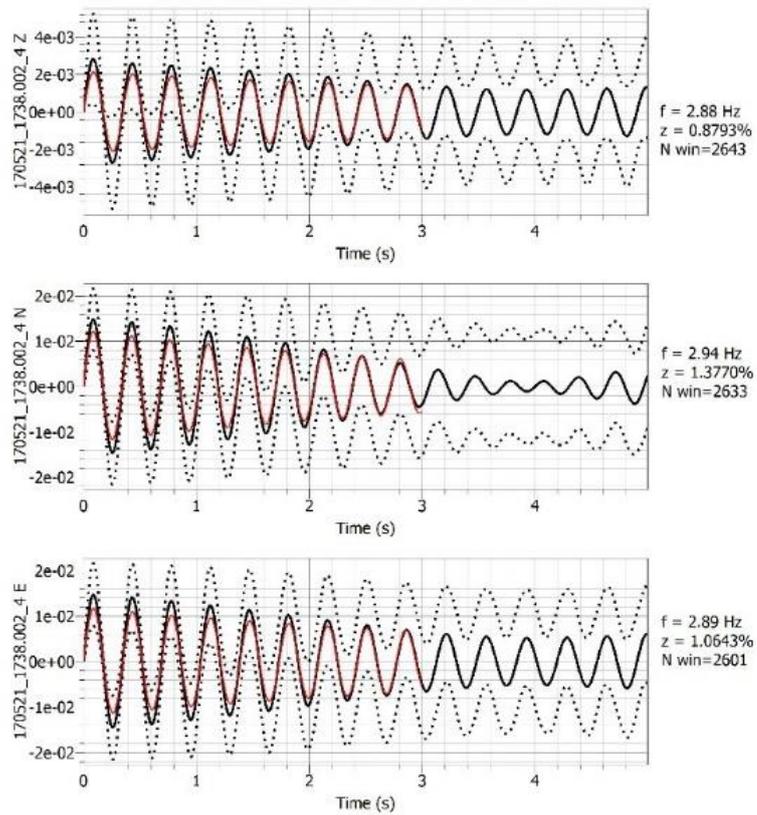
Figure 16S-Values of the damping coefficient at the recording point C9 between 2 Hz-3 Hz.

Directions	Frequencies / Hz	Damping / %
Vertical Z	2.88	0.87
Longitudinal NS	2.94	1.37
Transversal EW	2.89	1.06

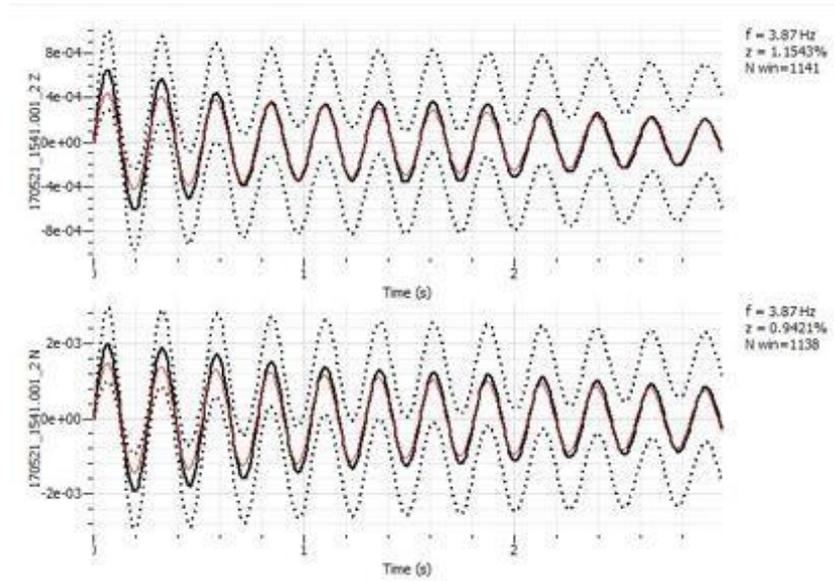
Figure 17S- Values of the damping coefficient at the recording point C9 between 3 Hz-4 Hz.

Directions	Frequencies / Hz	Damping / %
Vertical Z	3.87	1.15
Longitudinal NS	3.87	0.94
Transversal EW	negligible value	negligible value

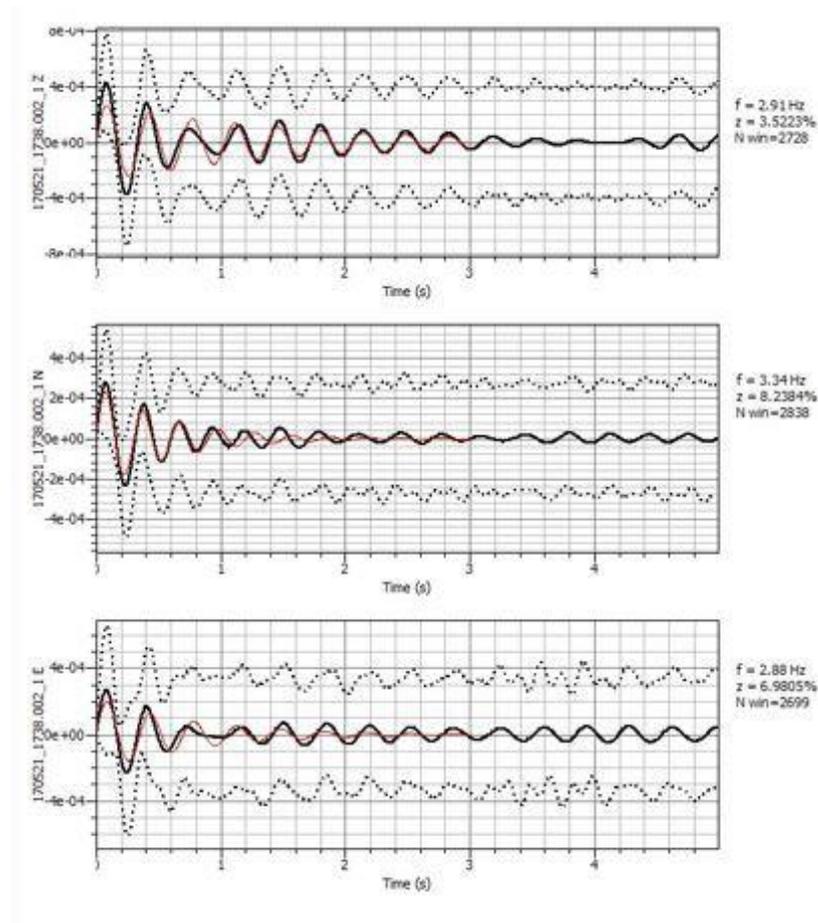
Figure 18S- Values of the minaret damping coefficient at the recording point C10.

Directions	Frequencies / Hz	Damping / %
Vertical Z	2.91	3.52
Longitudinal NS	3.34	8.23
Transversal EW	2.88	6.98

Minaret: For the minaret, and for the various frequency ranges from 2 Hz to 4 Hz, very low to low damping rates are reported, ranging from 0.31% to 3.52% for some sensors, and damping values within the range of recommendations for this type of structure ranging from 6.98% to 8.23% recorded in the C10 sensor (see Table 16 and supplementary material in Figure 18S).

The absence of a joint at the junction of each structure with the parent structure (the prayer hall) creates a visible overlap, giving rise to fears of hammering problems on the north and south flanks of the intital structure, leading to cracks. This phenomenon, to which unreinforced masonry is highly susceptible (Aşikoğlu, A., 2018; Paquette, L.G., 2012), may also explain the high damping values at some sensors. These cracks, mainly the hidden or invisible ones, bear tiny changes in frequency but up to 50% for the damping coefficient (Mikael, A., 2011). This was noticeable at the C2 and C3 sensors (see Table 2 to Table 7 and supplementary material in Figure 4S to Figure 9S), the C8 sensor (EW component) (see Table 13 and supplementary material in Figure 15S), and the C10 sensor (see Table 16 and supplementary material in Figure 18S).

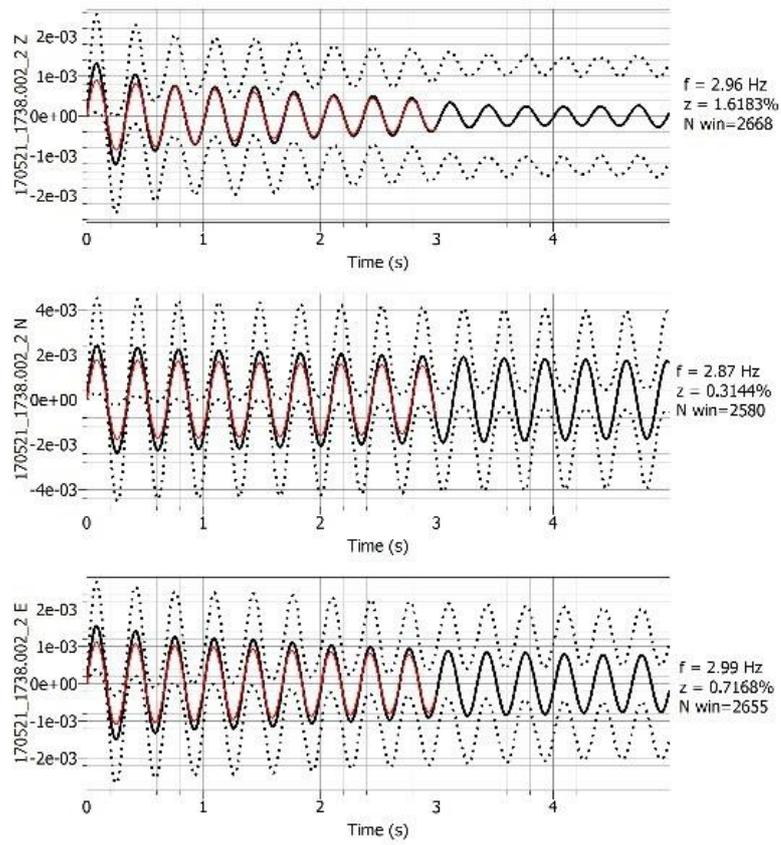
Figure 19S- Values of the minaret damping coefficient at the recording point C11.

Directions	Frequencies / Hz	Damping / %
Vertical Z	2.96	1.61
Longitudinal NS	2.87	0.31
Transversal EW	2.99	0.71

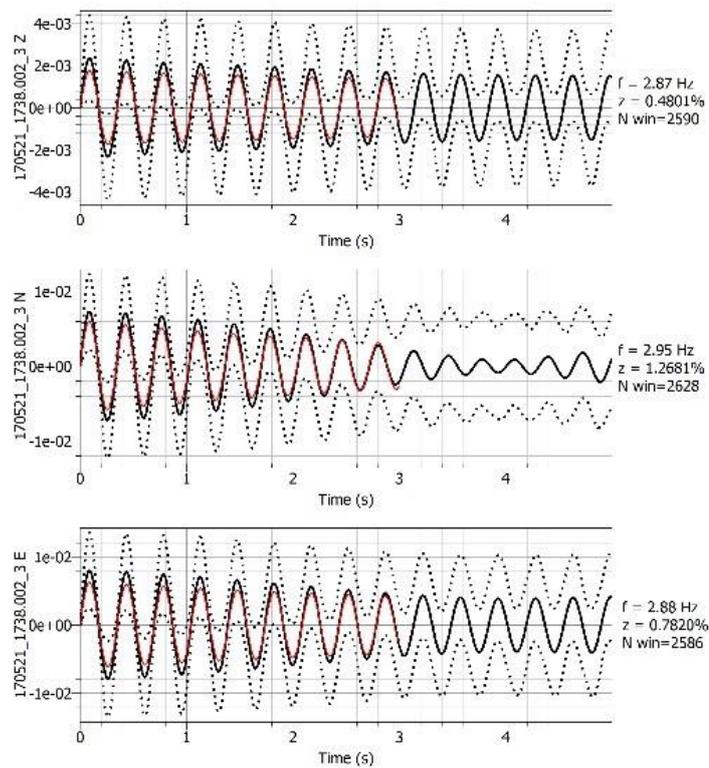
Figure 20S- Values of the minaret damping coefficient at the recording point C12.

Directions	Frequencies / Hz	Damping / %
Vertical Z	2.87	0.48
Longitudinal NS	2.95	1.26
Transversal EW	2.88	0.78

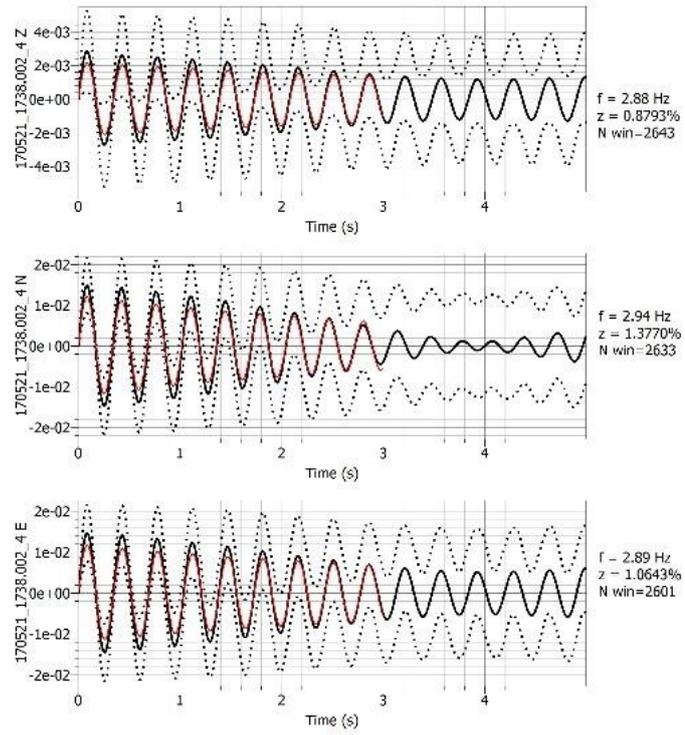
Figure 21S- Values of the minaret damping coefficient at the recording point C13.

Directions	Frequencies / Hz	Damping / %
Vertical Z	2.88	0.87
Longitudinal NS	2.94	1.37
Transversal EW	2.89	1.06
